INDUSTRY CORNER

MECHANICAL INSULATION CASE STUDY— TIMELY OPPORTUNITY FOR RETROFITS AND NEW CONSTRUCTION

Micah Lang,¹ Bud Fraser,² and Jeff Besant³

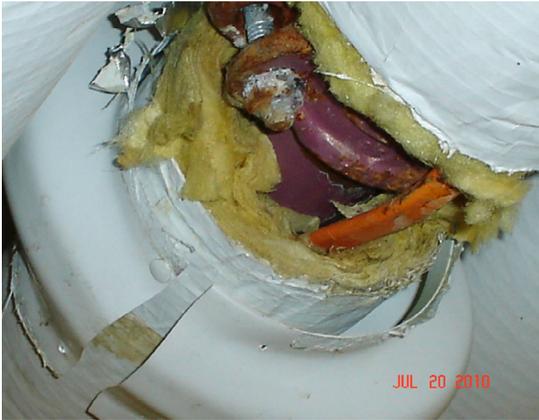
FIGURE 1. Corrosion and condensation in new LEED Platinum multi-family residential building.

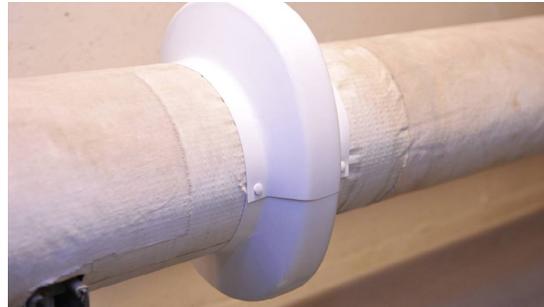
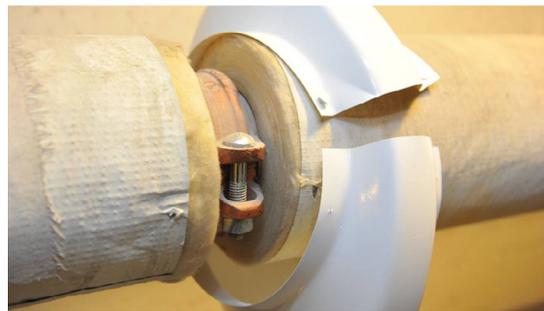
FIGURE 2. The top photo suggests the pipe is fully insulated. Underneath the PVC cover, however, there is no insulation around the fitting. (Public service organization building.)

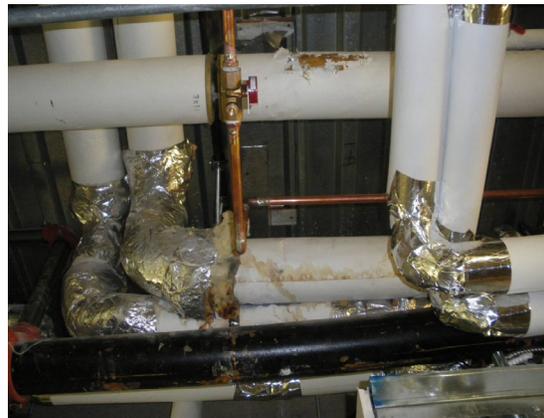
FIGURE 3. Sweating pipes with improper insulation and insufficient spacing in a medical building.

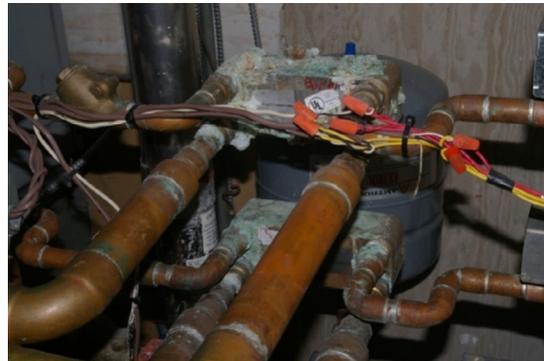
FIGURE 4. Example of *Building 1 Modeled Condition*: Detail showing heat exchangers used with domestic water system. Note the build up of deposits on the heat exchangers.

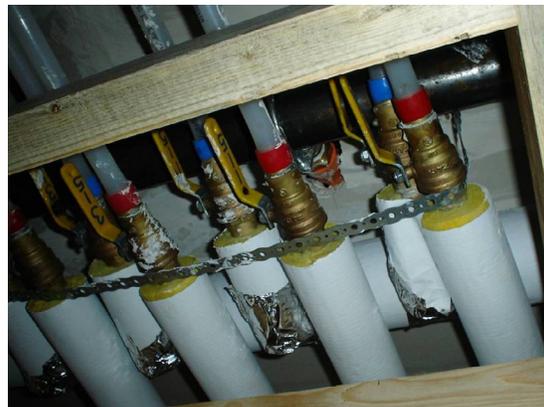
FIGURE 5. Example of *Building 2 Modeled Condition*: New domestic hot water pipes (risers) before drywall application—poor practice and material choice.

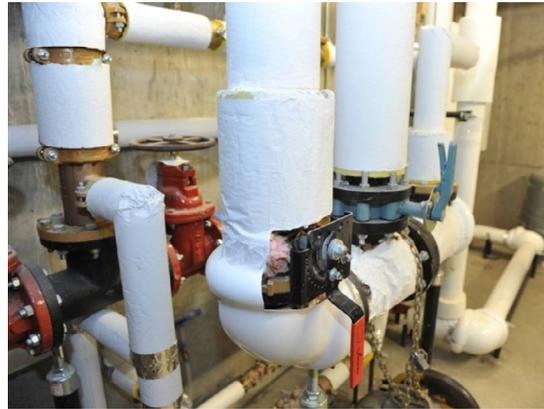
FIGURE 6. Example of *Building 2 Modeled Condition*: New mechanical room—poor practice and material choice.

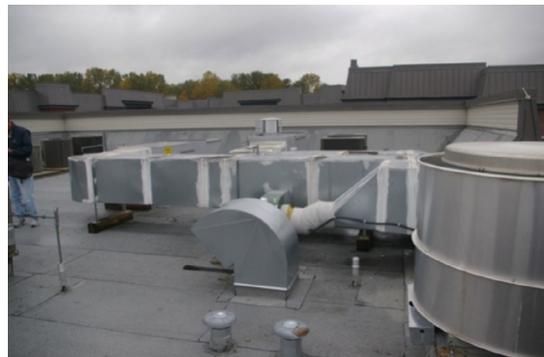
FIGURE 7. Example of *Building 3 Modeled Condition*: A section of an un-insulated supply air duct on a roof mounted make-up air unit.
